NSA-111paw
96V-129

Re: Toyota Tacoma Front Suspension
Part 573, Defect Information Report

DEFECT INFORMATION REPORT

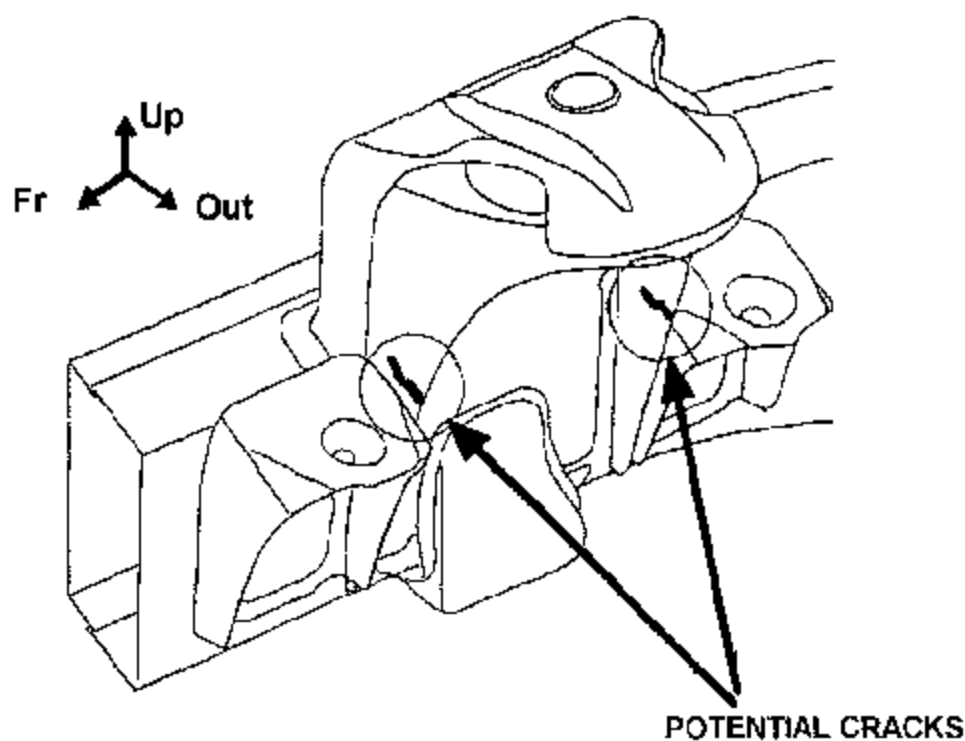
Diagram 4

4. Carefully conduct a visual inspection of the areas indicated (both driver and passenger sides) for any signs of cracking.
[See Diagram 4]
5. If there are no signs of cracking of the suspension support, the vehicle should be operated until the owner notification occurs and the vehicle is repaired.

If a vehicle is found to have any cracking of the suspension support, it must be physically inspected by a Regional Service Representative and if confirmed, further arrangements will be made through the Regional Customer Relations Department.

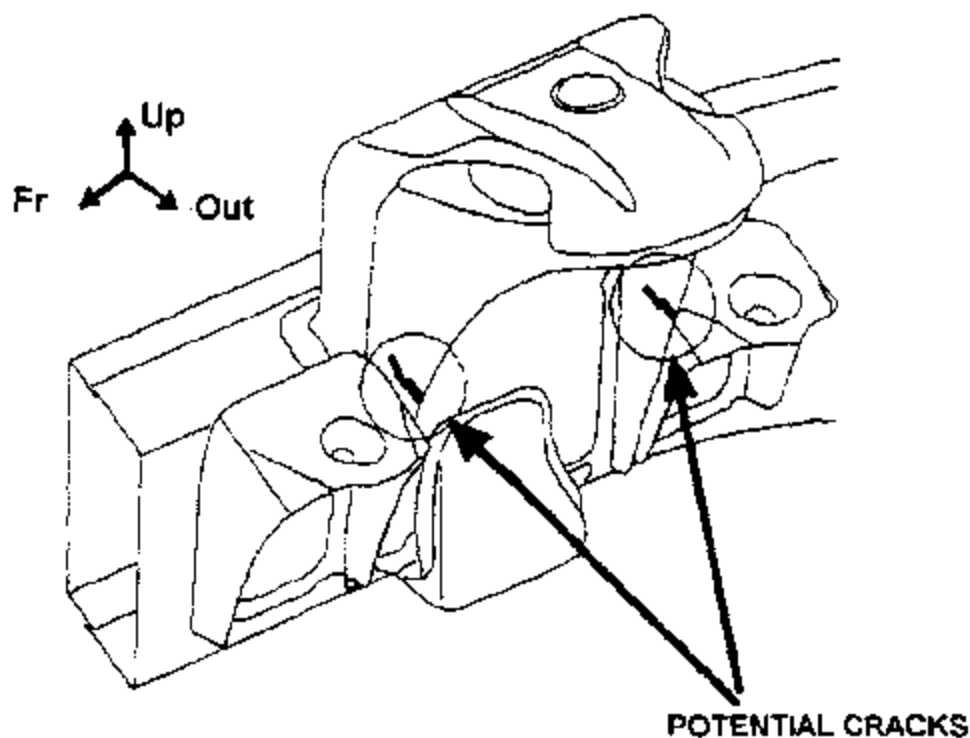
4. Carefully conduct a visual inspection of the areas indicated (both driver and passenger sides) for any signs of cracking.
[See Diagram 4]
5. If there are no signs of cracking of the suspension support, the vehicle should be operated until the owner notification occurs and the vehicle is repaired.

If a vehicle is found to have any cracking of the suspension support, it must be physically inspected by a Regional Service Representative and if confirmed, further arrangements will be made through the Regional Customer Relations Department.
